**North Slope of Alaska ARM Facilities
Monthly Status Update
Sandia National Labs**

September 2017

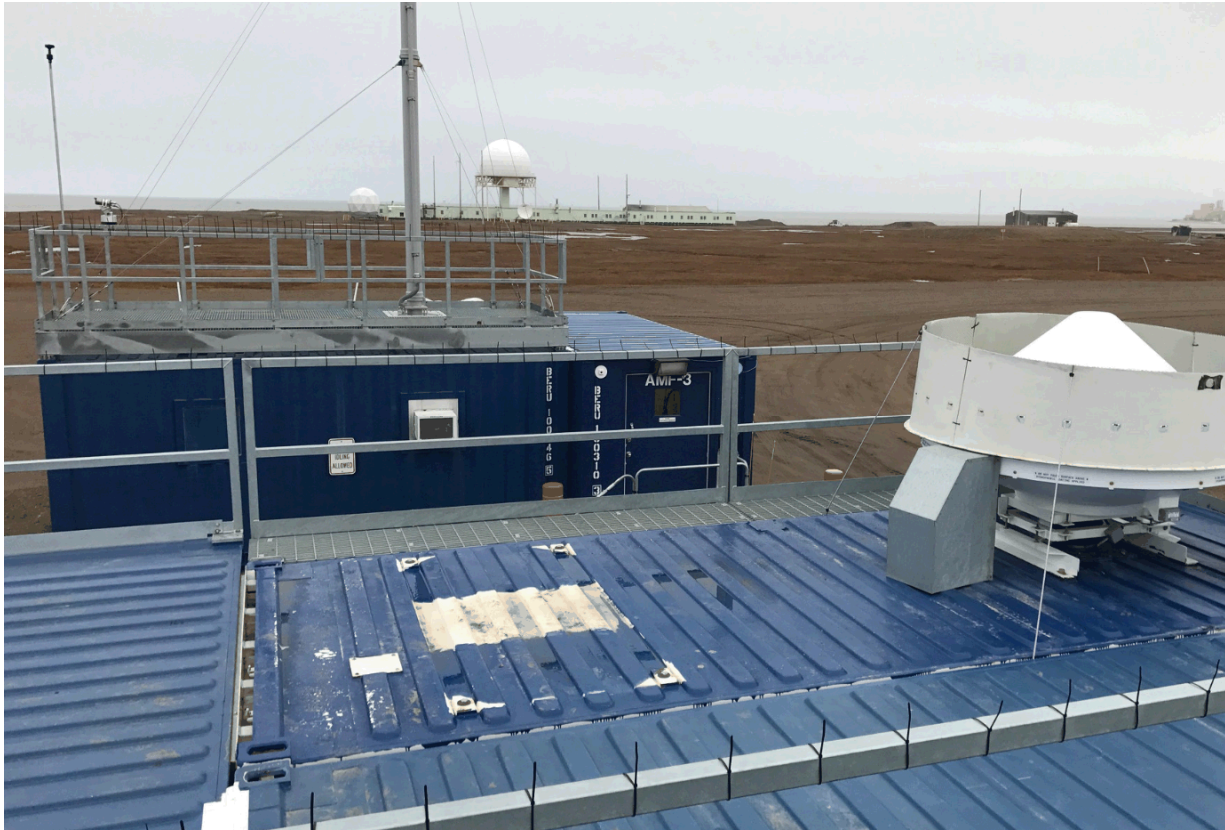
AMF3 SACRII pedestal was removed and will be stored for the winter in Deadhorse.

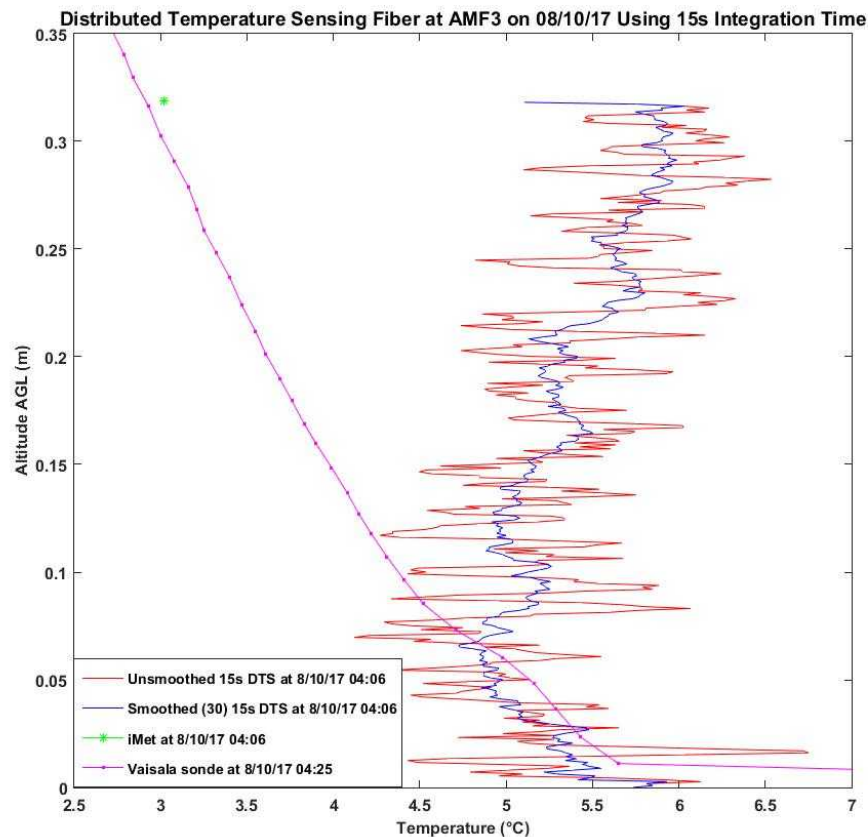
Analysis continued on August 2017 TBS and JUBA IOP data, in particular on the use of the rotary joint with the DTS measurements. The rotary joint is required in order to collect data while the balloon is in motion. The ground was identified with a heat tray during the August JUBA IOP, which acted to heat the DTS fiber and make the temperature measurements offscale high, as shown below.

It is yet to be determined if the measurement accuracy issue is completely due to the use of the heat tray, or if it could be due to loss within the joint itself. Towards that end DTS measurements were taken at Oliktok Point in September, at the Sandia Arctic Site, in order to determine the effect of the FORJ on the measurements. Two different DTS systems (Sensornet and Silixa) were operated while comparing FORJ and non-FORJ measurements in a glycol bath at the Sandia site. 30s, 1 minute, and 2 minute measurements were taken from both DTS systems with two FORJ fibers and one non-FORJ fiber in order to understand the relative accuracy of each DTS system and the impact of the FORJ on measurement accuracy. Accuracy should improve with longer measurement time. Tests were also conducted while rotating and not rotating the FORJs in order to understand if the loss through the joint, and thus the measurement accuracy, is affected when the joint is in motion. Analysis of this test is ongoing.

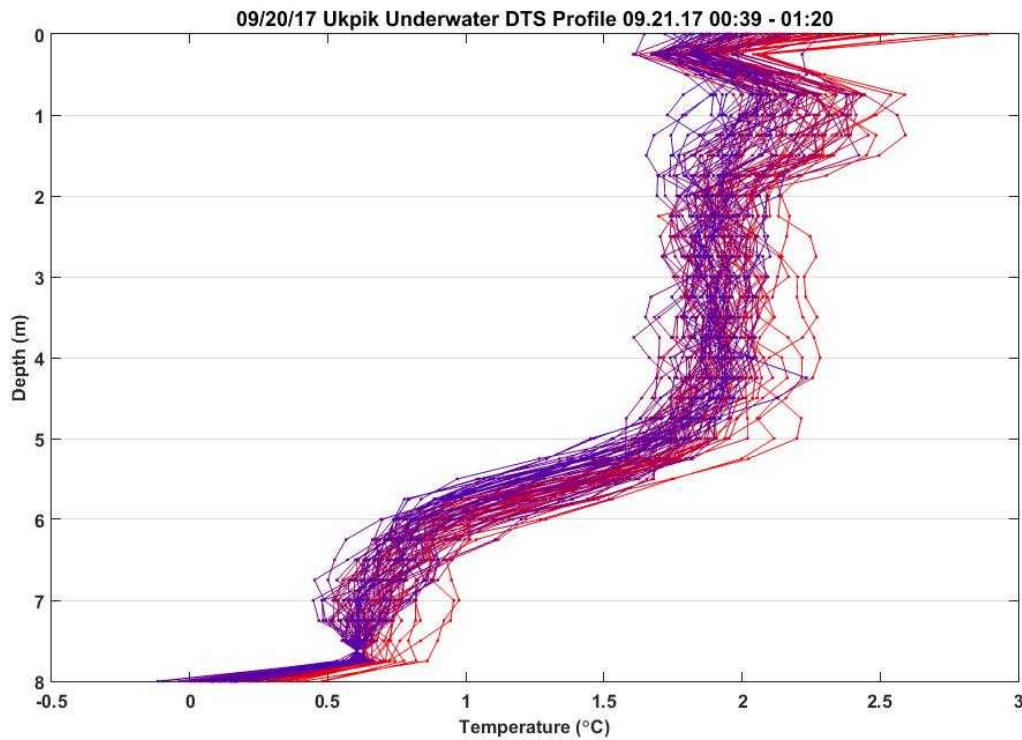
Figure 2: Submerged DTS profile from 09/20. Color goes from red to blue as time passes. Each temperature trace is a 30s interval. The spike in temperature around 1m could likely be from the Ukpik's exhaust.
